TIRE MARKING & PHOTO REQUIREMENTS

Supplement to Exhibit C of the UIIA

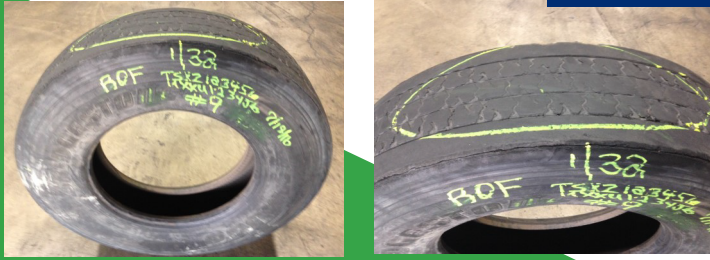
9-Slick Tread

Tread depths must be notated on side wall.

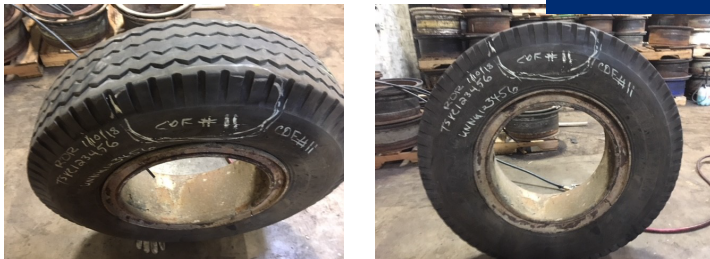
11-Blister

Pictures should be taken while tire is mounted and inflated on the equipment.

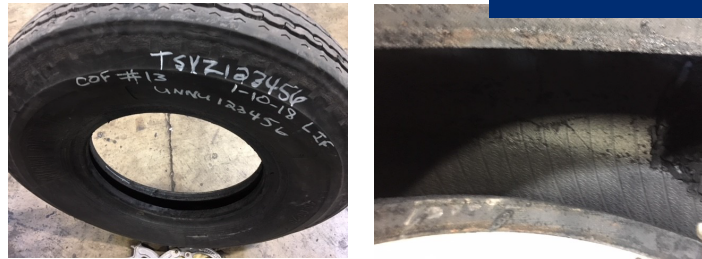
13-Run Flat

Pictures should be taken after tire is dismantled from the rim and additional photos taken of the inner liner.
