QWIK-E® Gladhand

Selecting the Right Gladhand to Help Prevent Corrosion

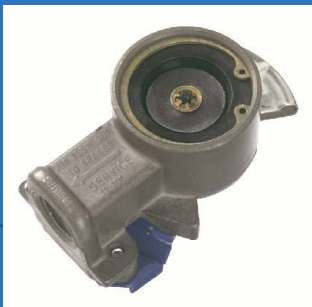
- Quick-release valve and gladhand combined
- Anodized housing for corrosion protection
- Trailer brakes are released up to 50% faster than with conventional methods
- For use with ABS and NON-ABS brake systems
